STATE PIPELINE COORDINATOR'S OFFICE

*Fiscal Year 2007
Lease Compliance
Monitoring Report*

ALASKA DEPARTMENT OF NATURAL RESOURCES

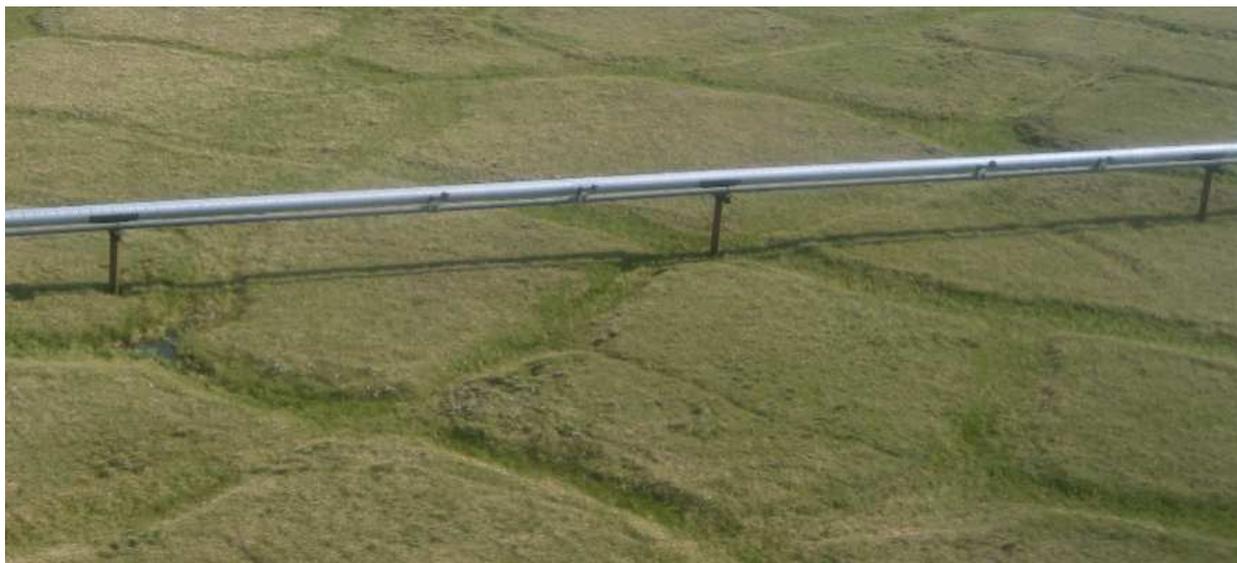
The Badami Sales Oil Pipeline transports crude oil from Badami to the Endicott Pipeline and crosses 25 miles of tundra. The pipeline was built in winter without the use of permanent gravel access roads. The Badami Sales Oil Pipeline and adjacent Badami Utility Pipeline are scheduled to temporarily discontinue service during August 2007.

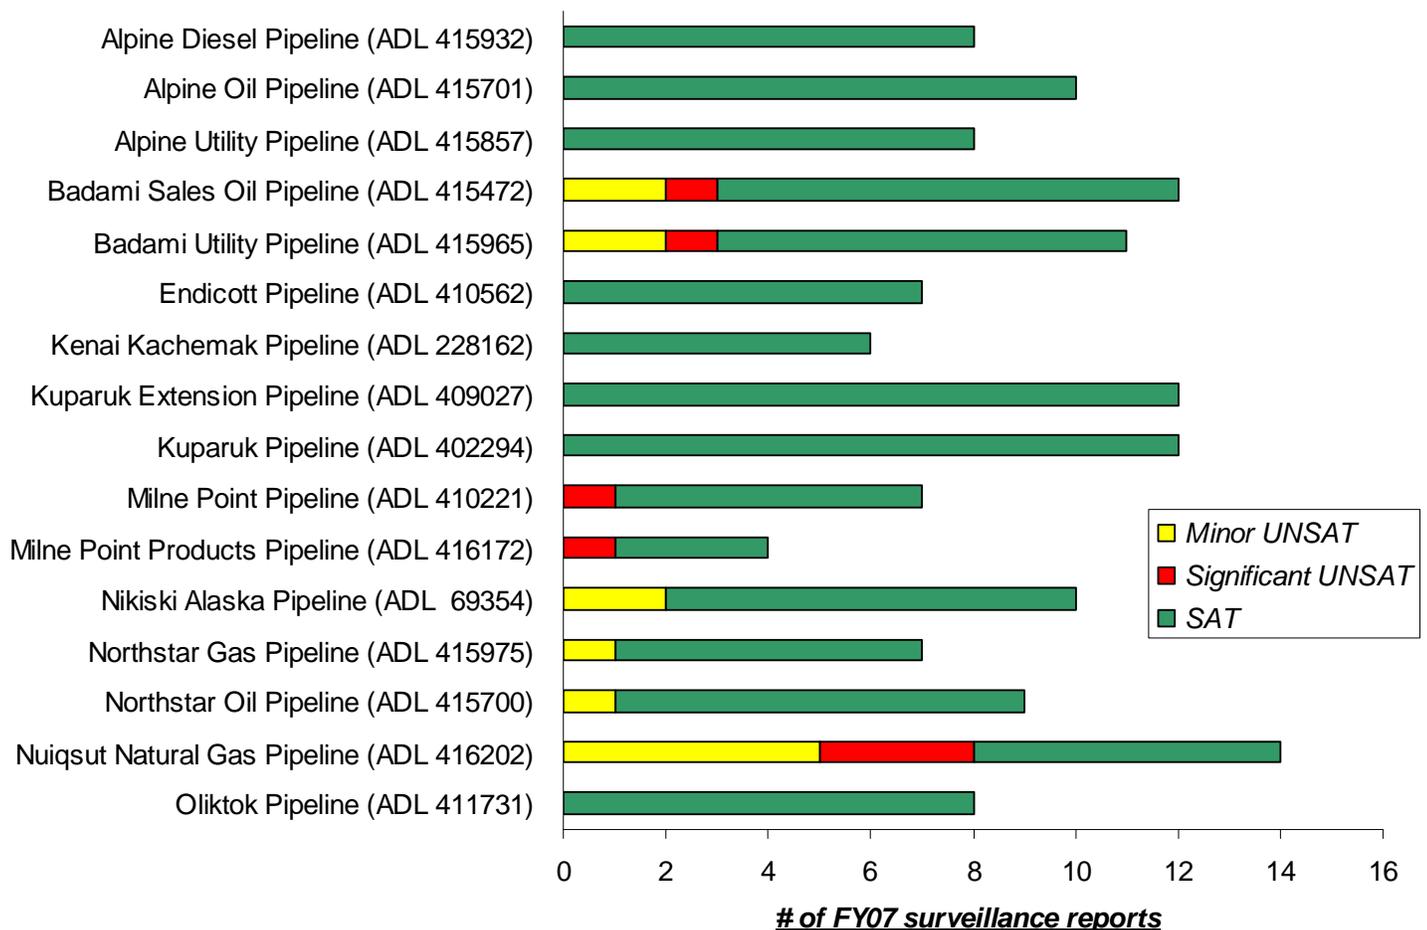
FY07 Surveillance Report Summary by ROW Lease and Pipeline

The chart above shows the number of surveillance reports that were signed during FY07 for each pipeline ROW lease subject to SPCO compliance monitoring. A surveillance report is described as "Minor UNSAT" or "Significant UNSAT" in this chart if at least one of the attributes described on that report were designated as such. Each report typically contains one to four attributes. Throughout the surveillance report summary tables in the SPCO annual report, surveillance reports are described as "UNSAT" if at least one attribute was found to be unsatisfactory. Each pipeline ROW was visited in the field at least once in FY07, though some were visited as many as four times. These field trips are described in the chapter for each pipeline.

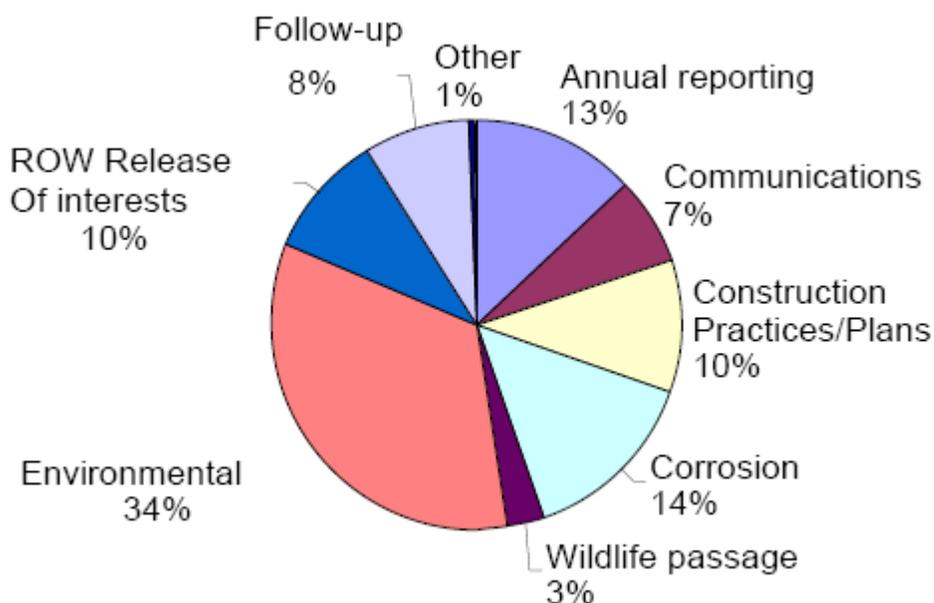
FY07 Surveillance Report Subjects (145 reports total)

Other important surveillance topics in FY07 included communications capability, surveillance & monitoring, quality assurance, ROW storage, public access, stream crossings, wildlife passage (for above-ground pipelines), maintenance practices, revegetation of disturbed areas, erosion control, procedure reviews, and worker and public safety. The chart below presents an approximate distribution of FY07 surveillance reports across broad categories.

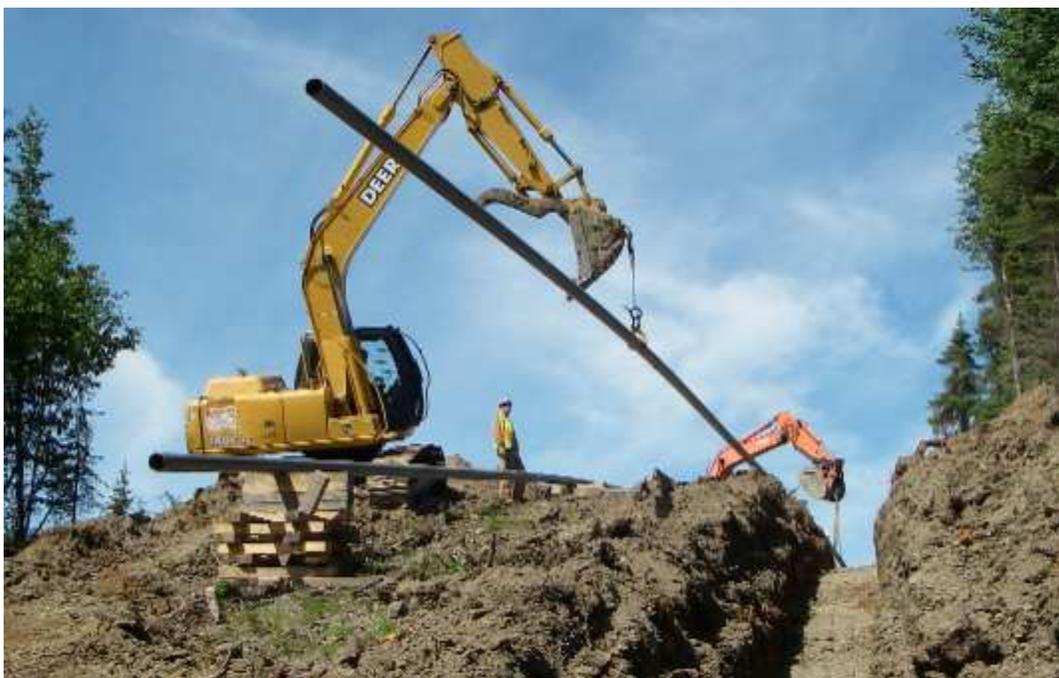
During summer 2006, construction was ongoing for the Kasilof Extension to the Kenai-Kachemak Pipeline, a high-pressure natural gas pipeline on the Kenai Peninsula.

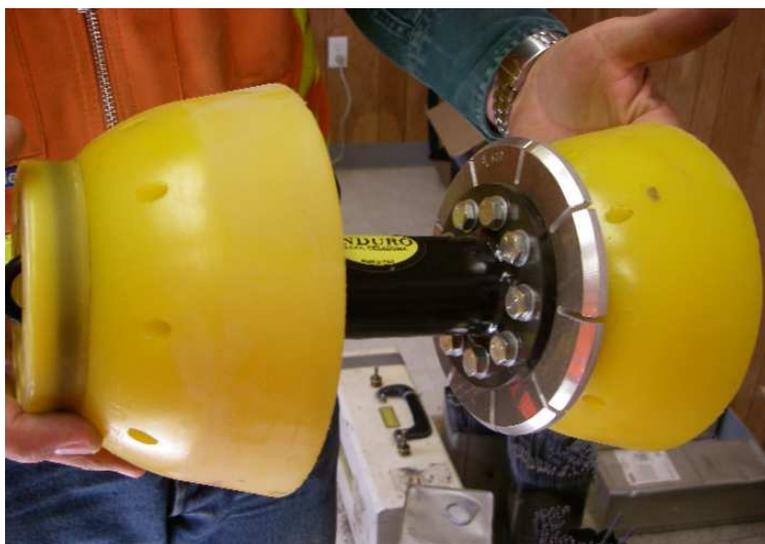
Left: this picture of a "gauging pig" was taken prior to the pig being run through the new 6" Kasilof Extension in August 2006. The metal plates between the two yellow polyurethane discs are designed to deform if they encounter a protrusion or reduced diameter in the newly constructed pipe. This picture was taken by an SPCO surveillant in July 2006 prior to the gauging pig run and system hydrotest the following month.

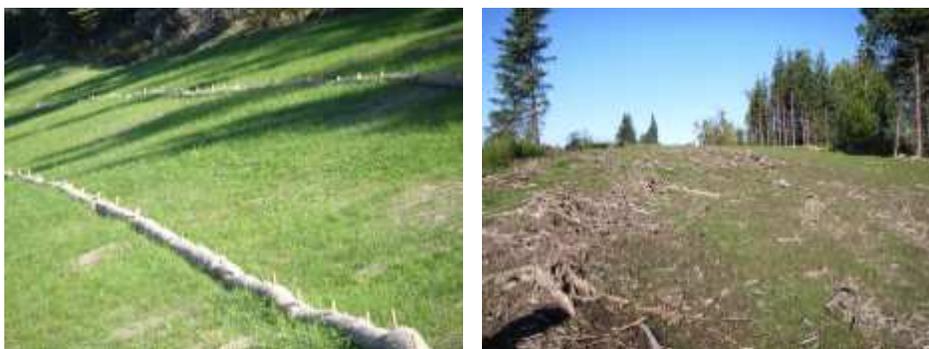
SPCO surveillance on September 12, 2006 evaluated revegetation efforts along the Kasilof Extension. Construction was completed during summer 2006 and by September, revegetation was well under way. The route will be re-visited in FY08.

September 12, 2006: An SPCO surveillant and two Lease Administration team members drove the entire KKPL ROW to review ROW conditions. Construction for the Kasilof Extension had already been completed and site restoration was reviewed. All conditions were reported as satisfactory (letter 06-297-WW).

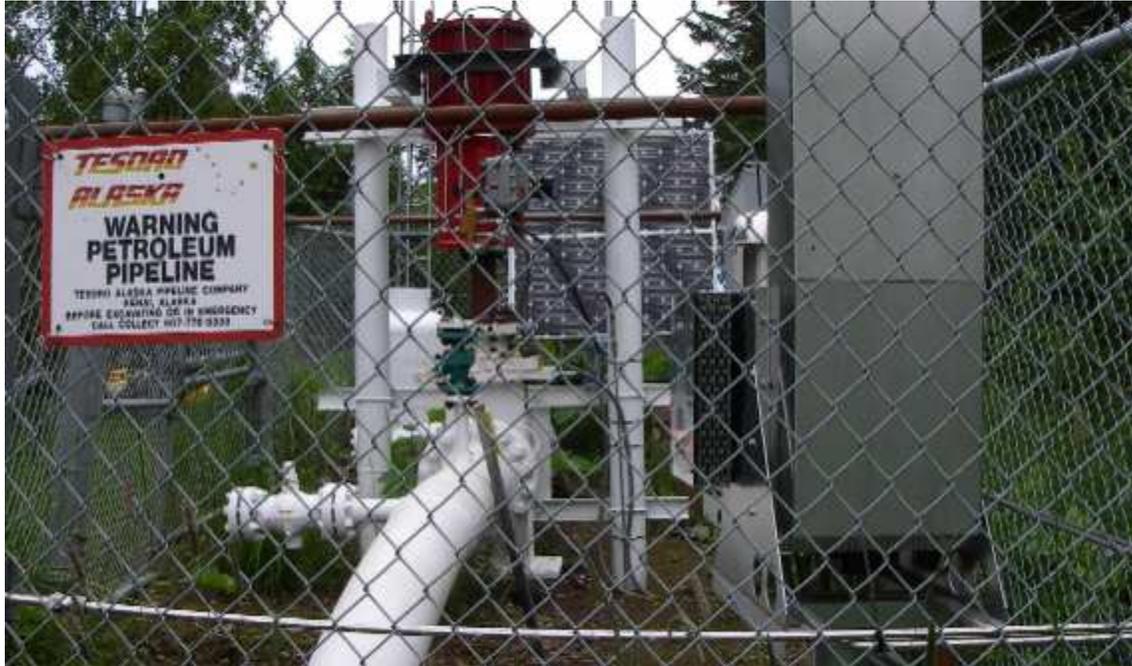
The Nikiski Alaska Pipeline transports refined petroleum products (jet fuel, diesel, gasoline, etc.) from the Tesoro Kenai Refinery to the Port of the Anchorage. The 70-mile pipeline is buried, and crosses Turnagain Arm from Point Possession to Point Campbell. Each of nine mainline valves are aboveground and fenced, such as the above remotely-controlled valve.

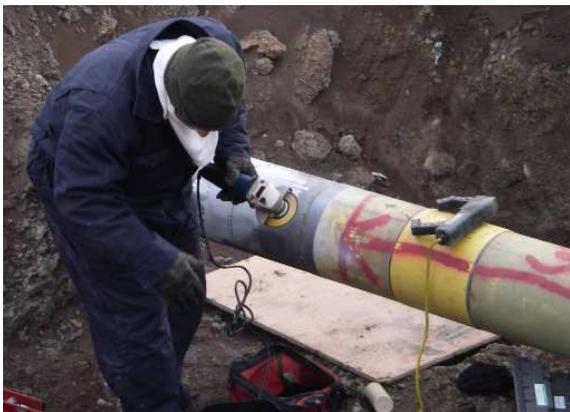
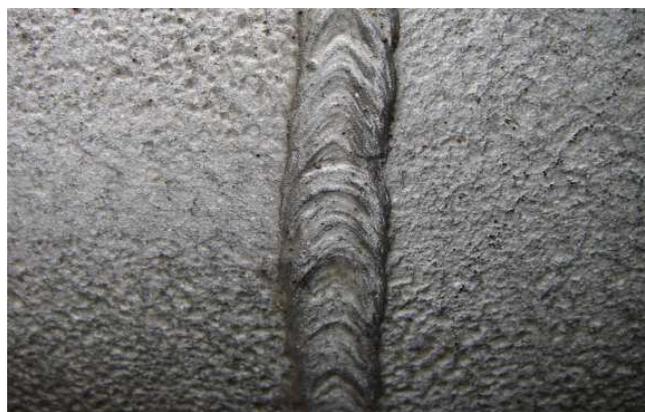
Above left: A contractor grinds in preparation for ultrasonic inspection work on the TAPL during a March 2007 integrity dig. **Above right:** after blasting and grinding, the bare metal pipe is visible at a girth weld. A pressure-containing sleeve was welded onto this location.

March 22, 2007: On March 19, the compliance team was notified the ILI tool had identified anomalies requiring immediate attention per the pipeline's USDOT integrity management plan. Contractors had been mobilized to the site on March 9 and had completed three out of four "immediate" digs by the time the compliance team was notified. The team traveled to the Kenai Peninsula on short notice to observe the integrity dig work. Lease stipulation 1.16.1 (2) requires the SPCO to be notified immediately of any condition, problem, malfunction, or other occurrence which in any way threatens the integrity of the pipeline. Because this notification was not received, 07-SPCO-S-037 describes an unsatisfactory condition (letter 07-053-WW). During the surveillance, the team witnessed sandblasting, grinding, ultrasonic inspection, and fit-up and welding of a pressure-containing sleeve.

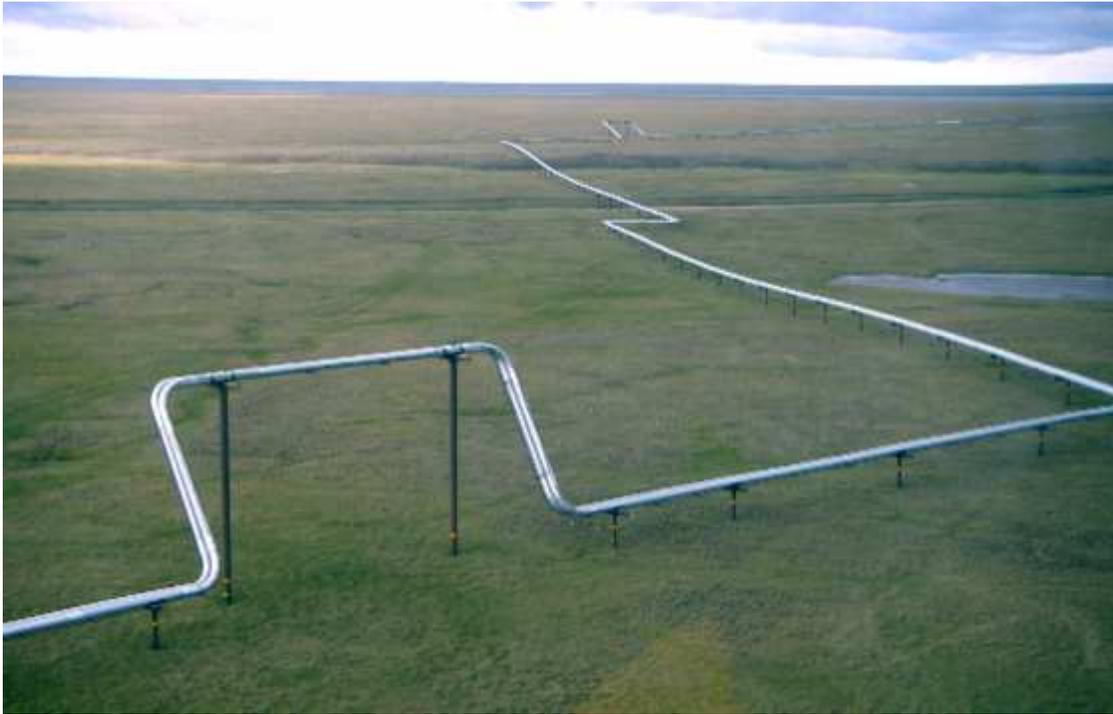
The Alpine Pipelines connect the North Slope's westernmost development, Alpine, to infrastructure in the Kuparuk River Unit.

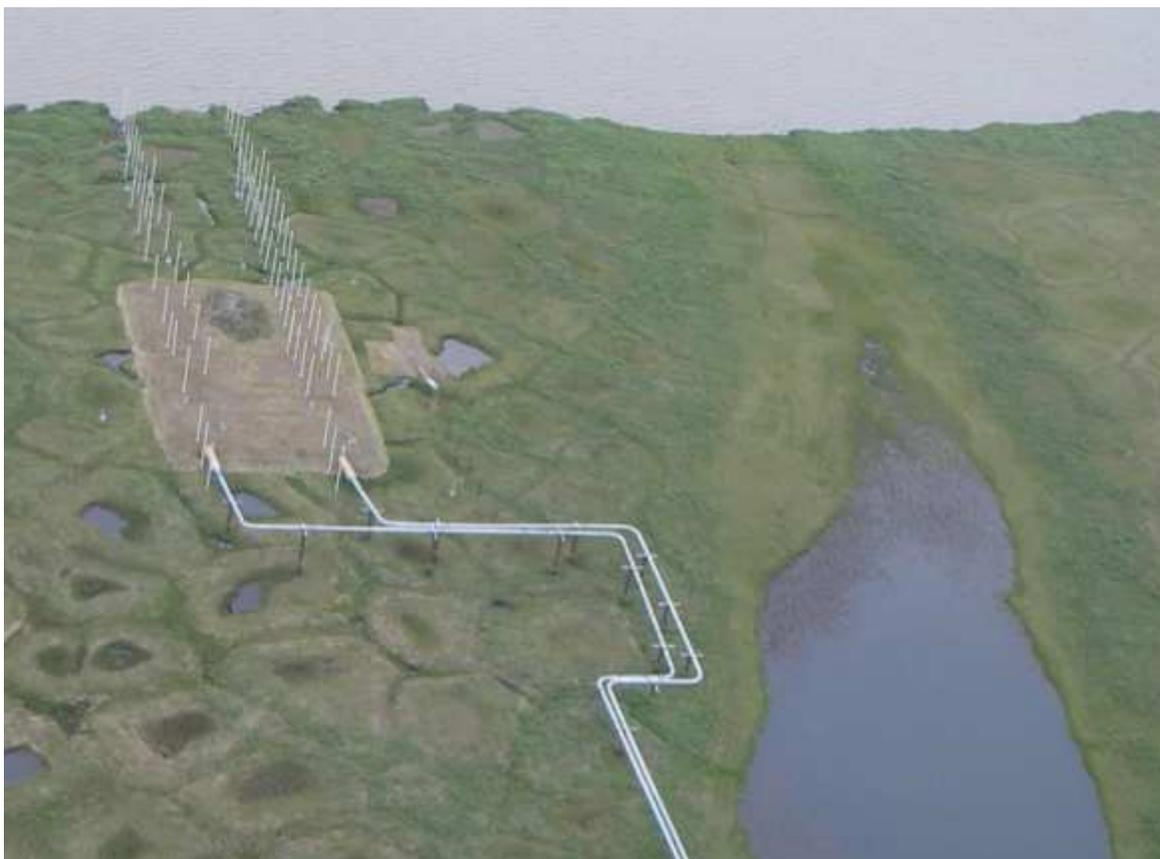
The Alpine pipelines demonstrated the North Slope's first pipeline river crossing using horizontal directional drilling (HDD). The pipelines are installed inside steel casing that was bored underneath the riverbed, 85 feet below grade. In the above photo, thermosiphons are visible above the Utility Pipeline (left) and Oil Pipeline (middle). Also known as "heat pipes," these help keep the permafrost frozen. The Diesel Pipeline transitions to below-ground on a smaller gravel pad to the right of the main pad. This picture was taken from the air on the east side of the river, facing west. HDD crossings are not as susceptible to erosion as trenched crossings. This particular location is within the Colville River floodplain. A trenched crossing would be at risk for erosion during floods, as has happened at the Badami Pipelines' crossing of the East Channel of the Sagavanirktok River (see Chapter 5). A channel similar to the one which eroded across the trench backfill at the Badami crossing is visible in the above photo on the right.

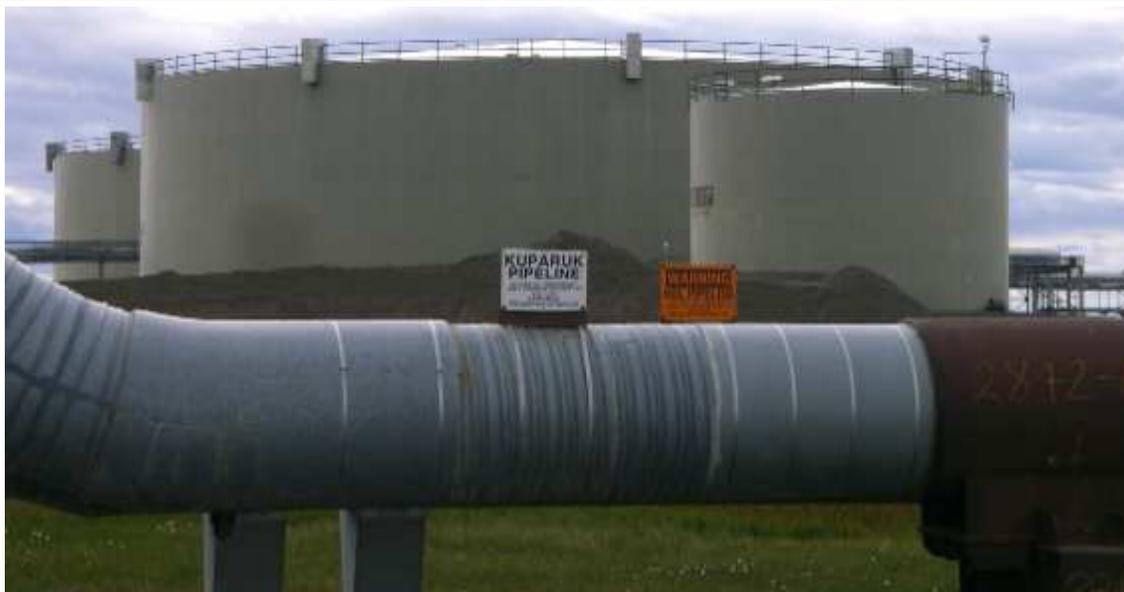
The Kuparuk Pipeline and Extension transport processed crude oil from Alpine, Milne Point, and Kuparuk to Pump Station 1. The Oliktok Pipeline transports natural gas liquids to Kuparuk.

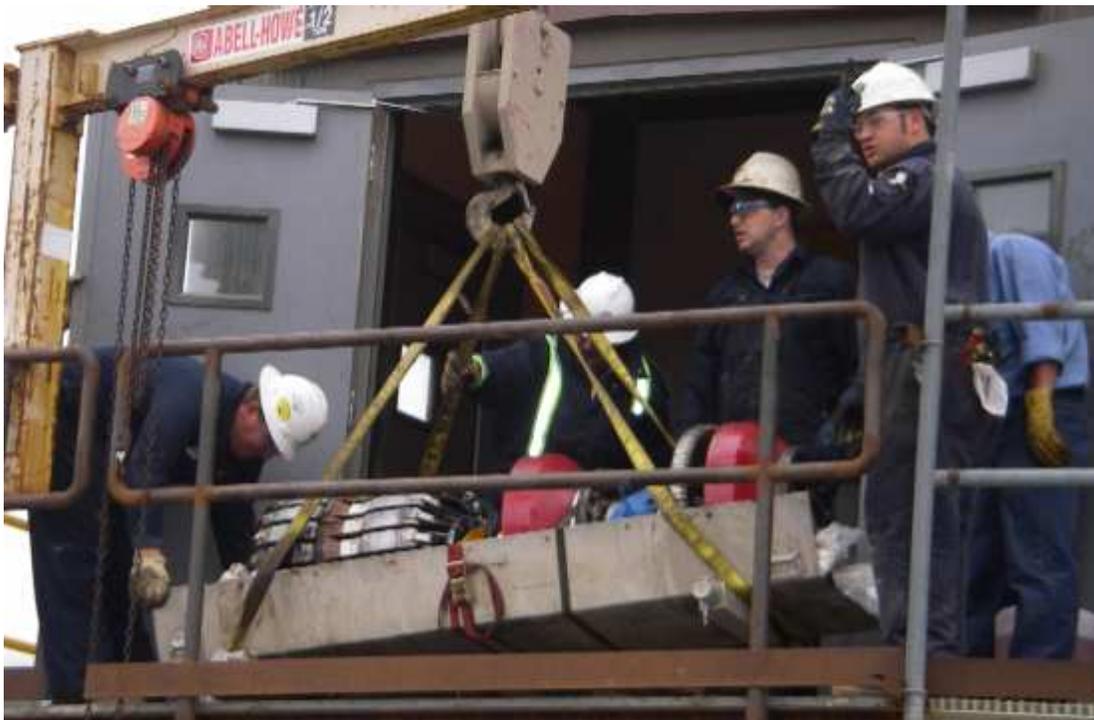
In August 2006, the compliance team attended the launch and retrieval of this magnetic flux leakage in-line inspection tool. The tool is pictured here being removed from the pig receiver module by a crane onto a flatbed truck.

KPL In-Line Inspection: Data analysis from the 2006 pig run indicated no immediate threats to pipeline integrity. Of eight anomalies evaluated, the worst wall loss was 38%. CPAI also inspected numerous potential external corrosion locations with wet insulation. One location was refurbished. There are currently 40 sleeves welded onto the KPL.

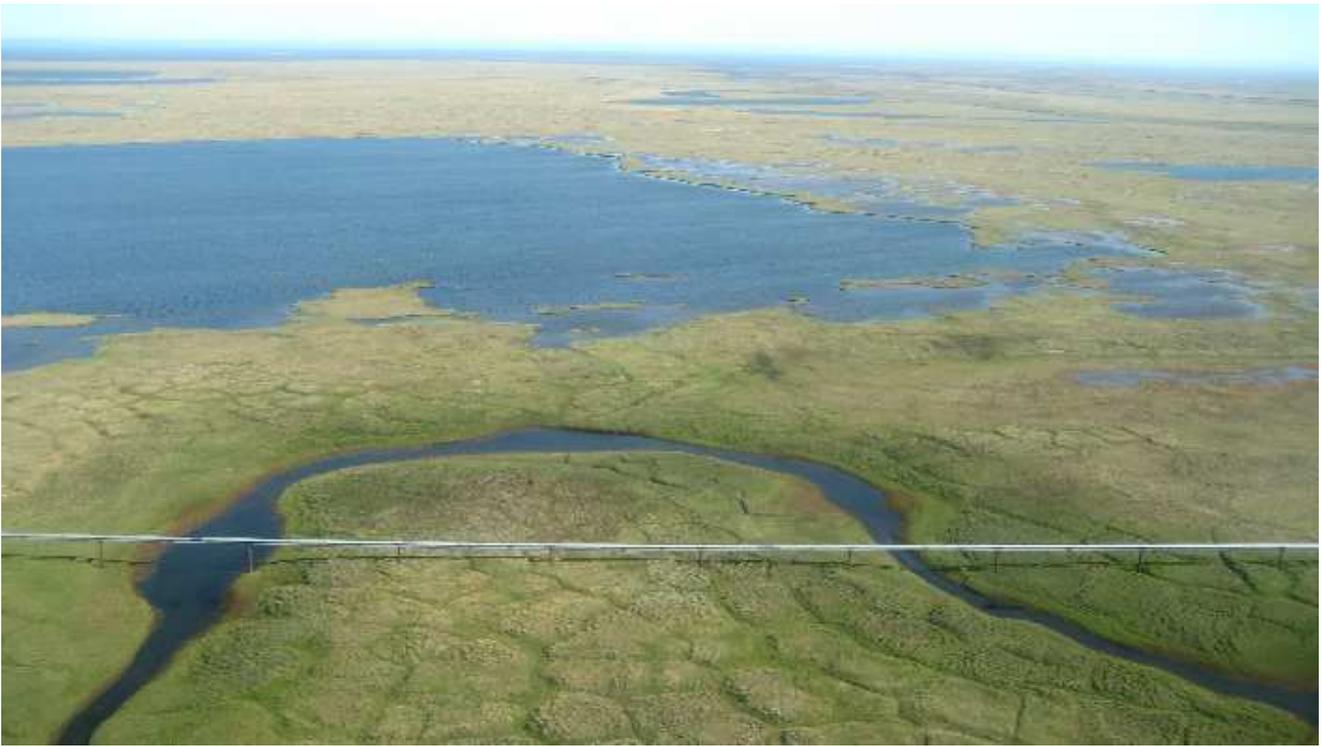
The Badami Pipelines connect the North Slope's easternmost development, Badami, to infrastructure at Endicott. The pipelines cross 25 miles of roadless tundra.

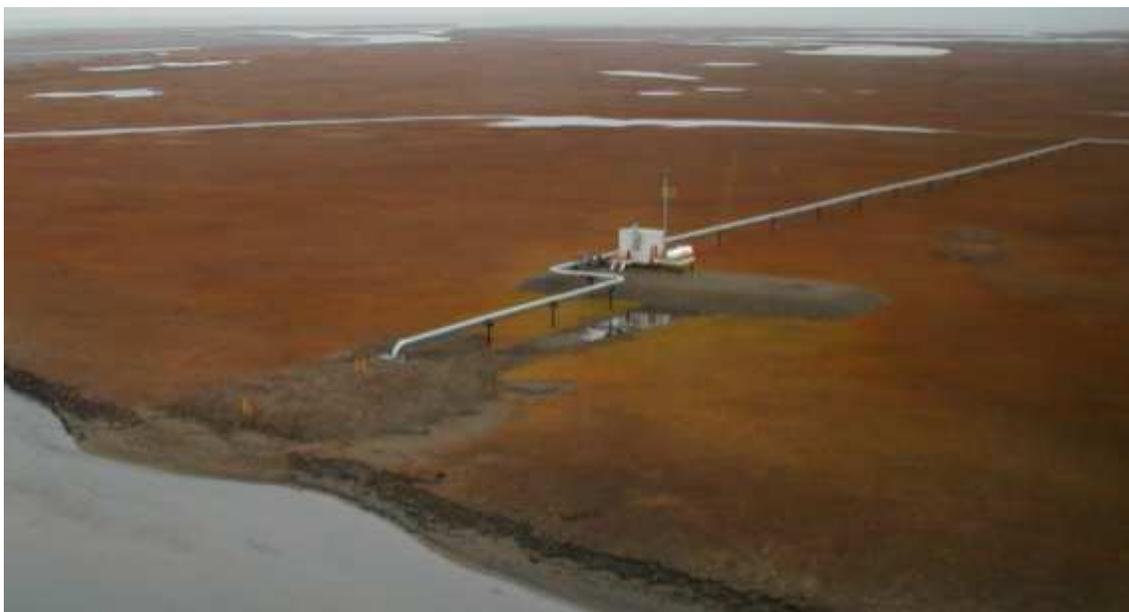
Above, remotely operated valve RTU-2 is located on the East Bank of the East Channel of the Sagavanirktok River.

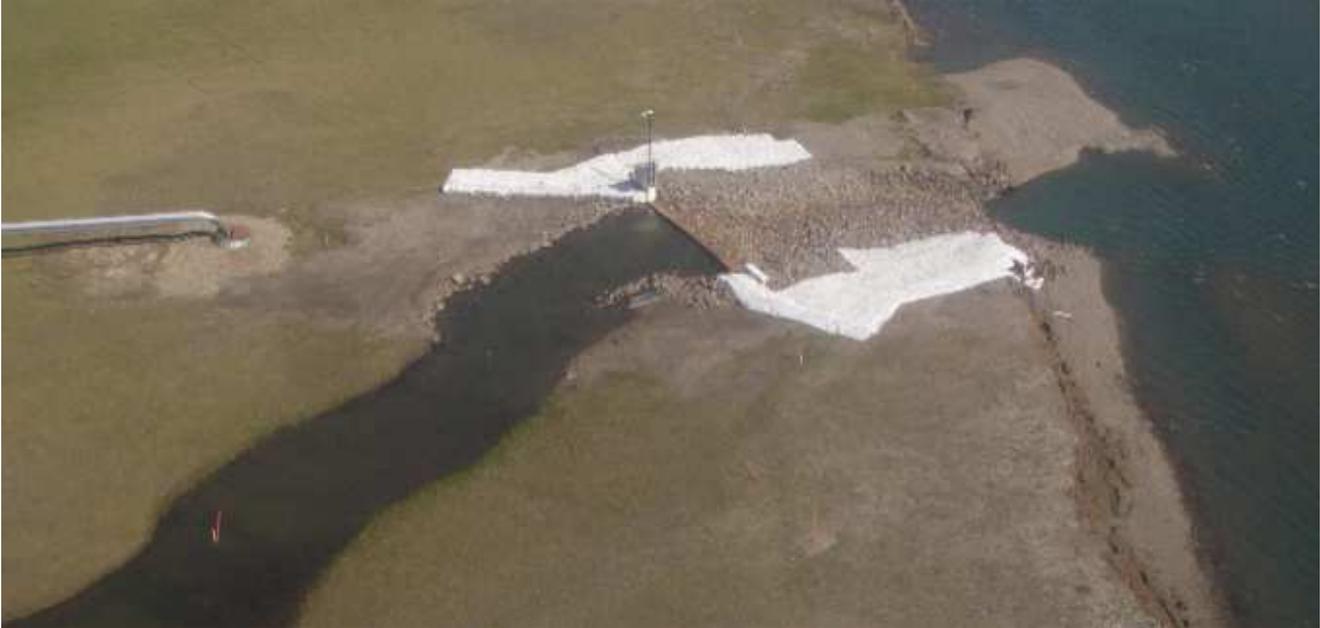
The Badami Weir was built to prevent erosion of the pipeline backfill at west bank of the pipelines' Sag River crossing. This photo from July 13, 2007 shows the weir after interim corrective action temporarily stabilized the site. BPTA is currently working on a long-term solution.

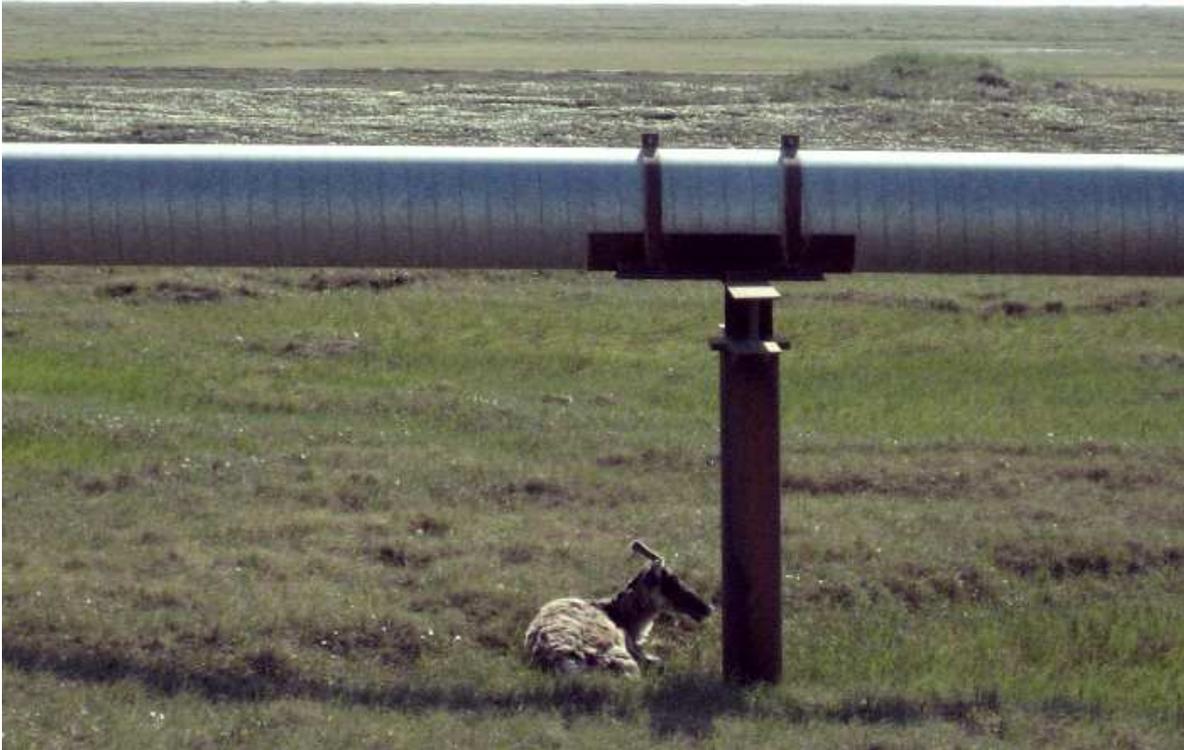
The 26-mile long Endicott Pipeline transports crude oil from man-made Endicott Island to TAPS.

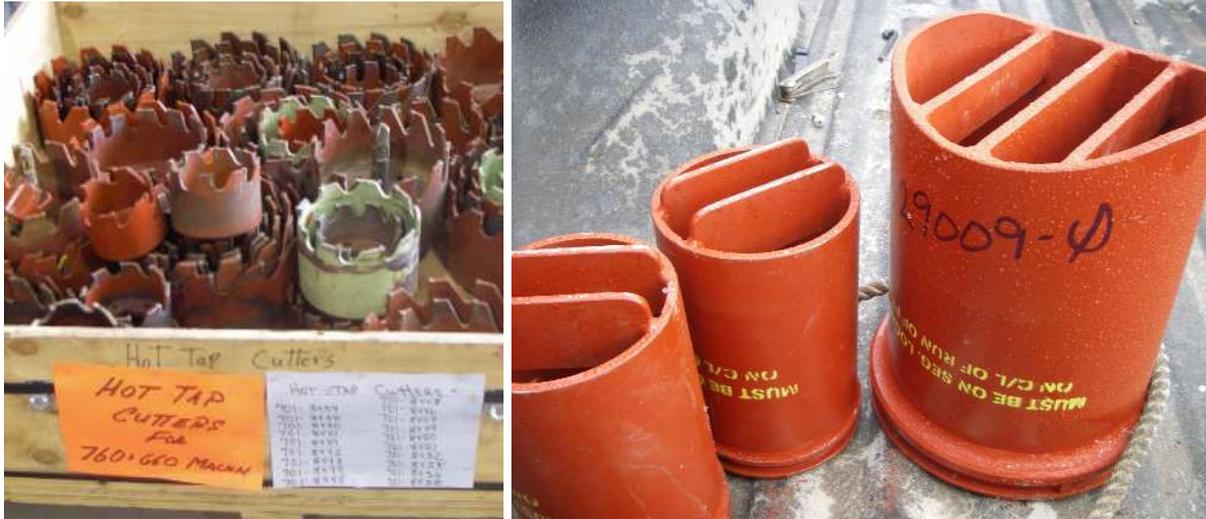
The above photos are from surveillance of the Construction Authorization for the Endicott Pipeline Connections. **Above left:** "cutters" of various sizes for the hot tap machine that was used for the FS-2 connection. **Above right:** these "pig bars" prevent a pig from diverting into a pipeline connection. Pig bars were required as part of the Authorization.

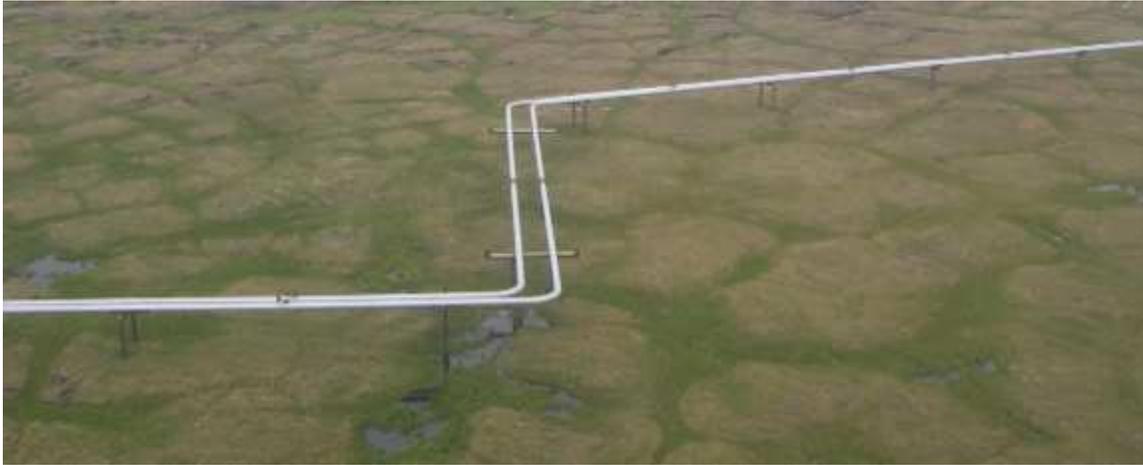
The Northstar Pipelines connect man-made Northstar Island to Prudhoe Bay infrastructure. Northstar Island is approximately six miles offshore in State waters in the Beaufort Sea.

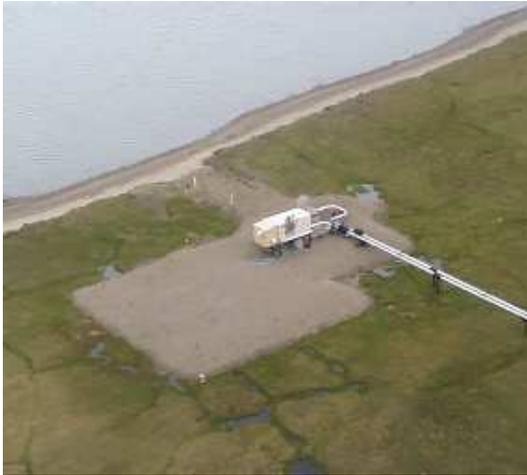
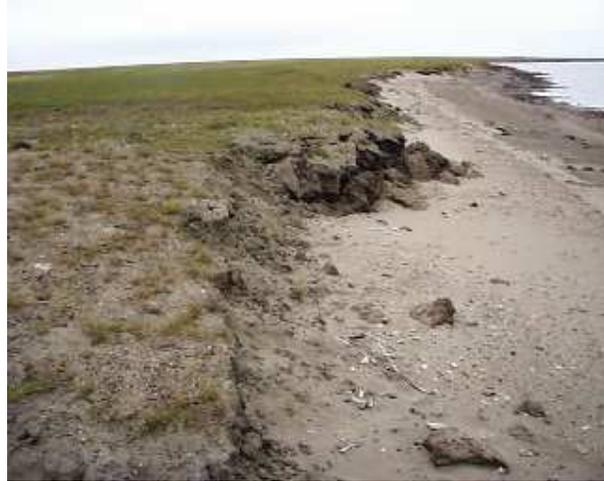
Left: Aerial view of the Northstar shore crossing landfall at Point Storkersen, the point where the pipelines transition between buried sub-sea and supported above-ground. The visible module houses a remotely-operated valve. **Right:** close-up of naturally eroding bluff near the pipelines' shore crossing. The lessee conducts an annual bluff stability survey.

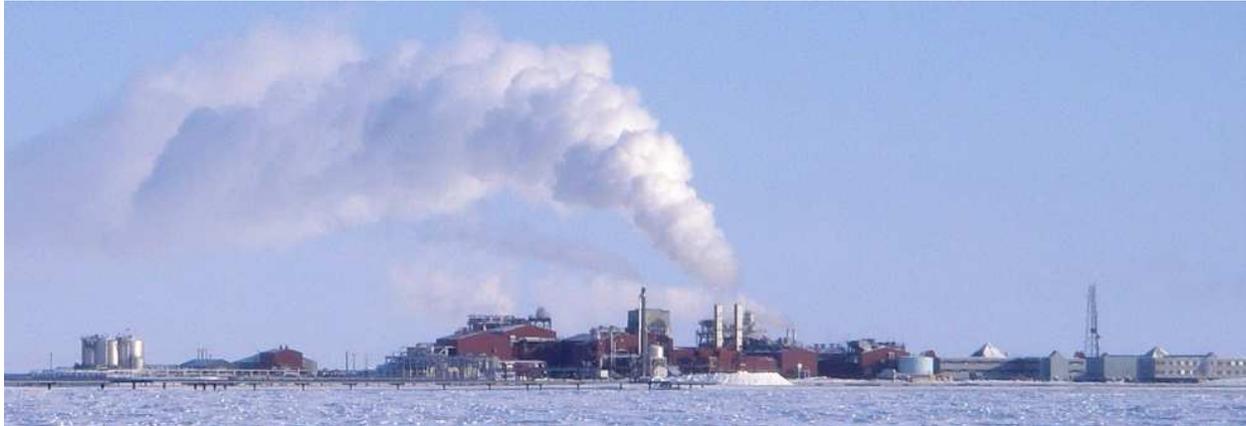
The Milne Point Pipelines connect the Milne Point Development (Central Facilities Pad pictured above) to the Kuparuk and Oliktok Pipelines.

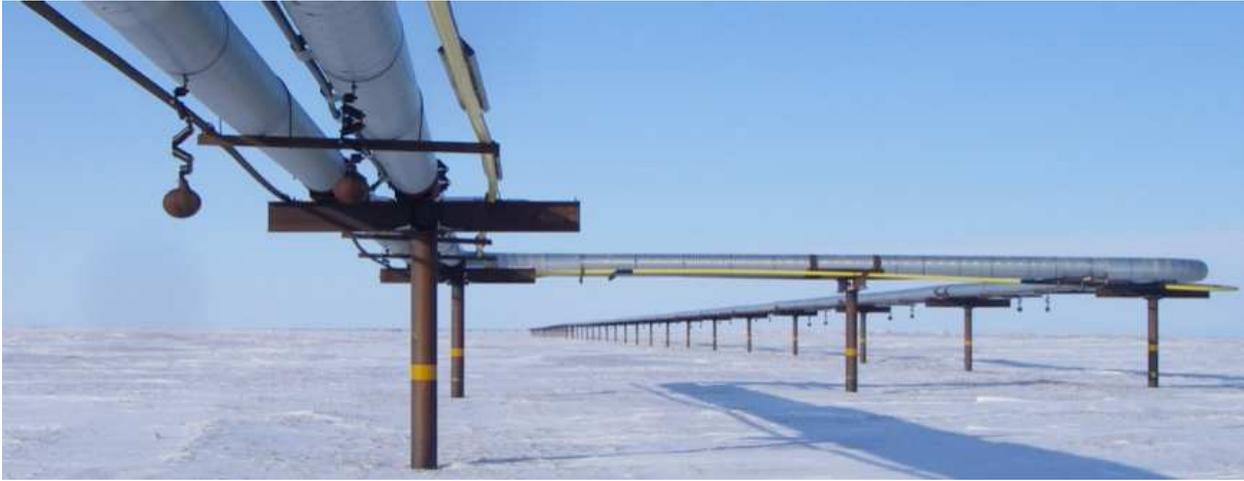
The above-ground portion of the Nuiqsut Natural Gas Pipeline (yellow) is located on the same horizontal and vertical supports as the Alpine Pipelines west of the Colville River. Where the Alpine Pipelines cross the Colville River, the NNGP diverges and continues, buried, to Nuiqsut.

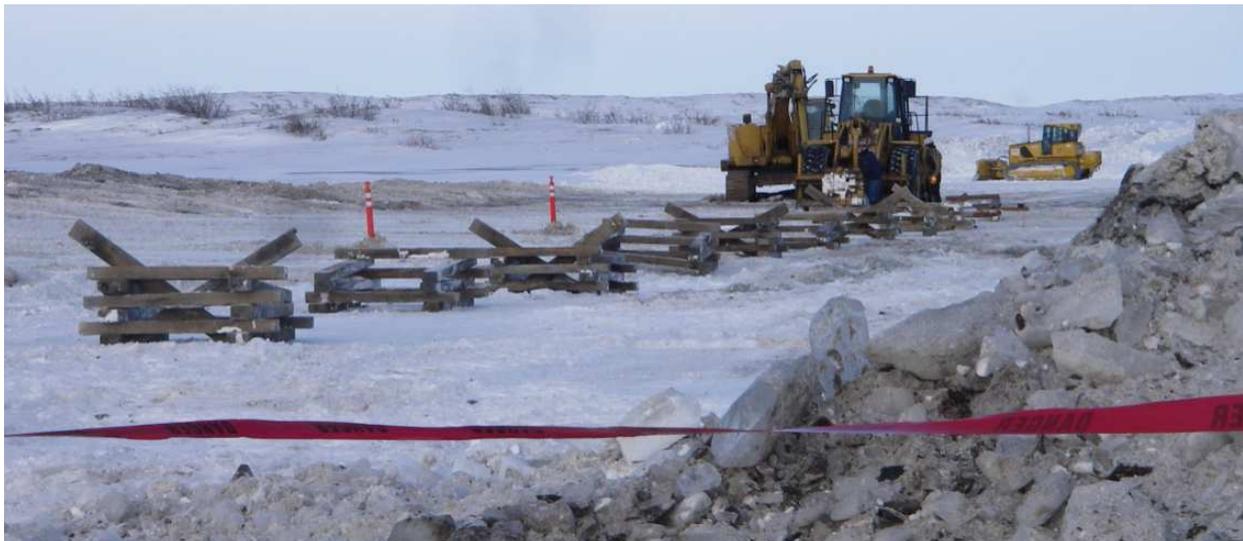
Repair work at the Nechelik Channel was ongoing in March and April 2007. In this photo, from foreground to background: red tape marks the edge of an excavated bell hole where the new string of pipe will be welded onto the existing pipeline ("tie-in"). Ice excavated from the hole is piled to the right. Temporary wooden pipe supports have been built and the new pipe will be laid on them during fabrication. Snow removal continues in the background.

As required by Lease Section 14 and Stipulation 1.3.1, the NSB submitted the *DRAFT Nuiqsut Natural Gas Pipeline Channel Crossing Repair Construction Plans in Support of Right-of-Way Lease (Plan)* for SPCO review dated March 6, 2007. In letter 07-042-WW on March 22, 2007, the SPCO provided comments on the draft. This letter included twelve numbered requests, and also asked the NSB to provide one week's notice prior to mobilization to allow the compliance team time to schedule surveillance. The letter also stated, "Please be aware that this is not the final approval of this plan, and an approved plan must be in place before commencement of the scheduled repair work." Contrary to this statement and to the Lease, the NSB began and largely completed work before the plan was approved. Many of the requests in 07-042-WW were also not answered. This is further discussed in the Compliance Oversight section.

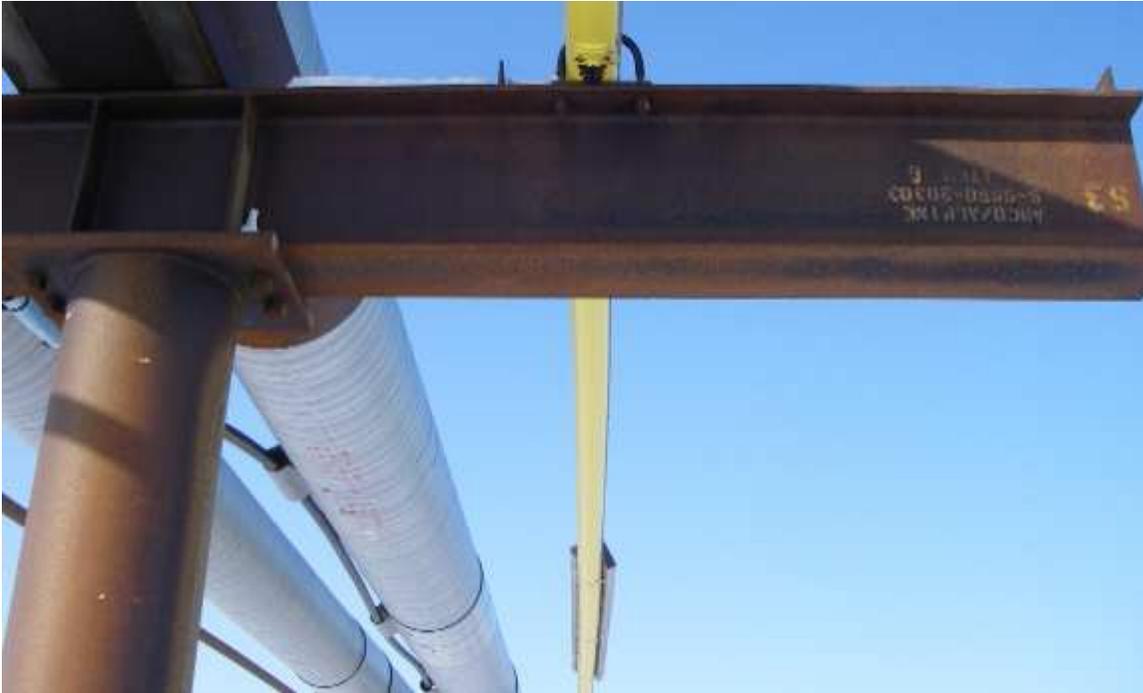
The NNGP is pictured here in the shared ROW with the Alpine pipelines (left) just north of the Alpine HDD site on the west side of the Colville River. As reported in letter 07-051-WW, the NNGP has suffered coating damage in some locations where pipe movement across the horizontal support appears to have scraped off coating. The wooden structure attached to the NNGP in the background of the photo is a vibration dampener.
